NEW JERSEY DEPT OF ENVIRONMENTAL PROTECTION TRENTON
NATIONAL DAM SAFETY PROGRAM. LAKE WADSWORTH DAM (NJ 00433), DEL--ETC(U)
AUG 79 F K JOLLS

LAKE WADSWORTH DAM
NJ 00433

PHASE 1 INSPECTION REPORT
NATIONAL DAM SAFETY PROGRAM

August, 1979

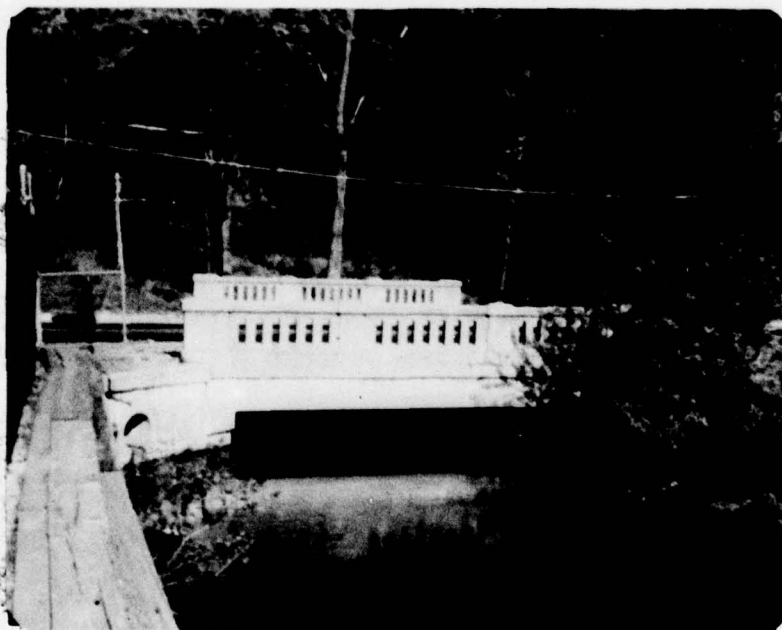
Bridge at Delsea Drive. Single span culvert (clear opening 20 x 4).	Built in 1929. Channel heavily silted up. Inadequate hydraulically and should be cleaned out.
---	---

View of Highway Culvert Approx. 150' Downstream from Dam

(5) The downstream culvert under Delsea Drive should be excavated by the New Jersey Department of Transportation to restore its designed hydraulic capacity.
